PHOTOGRAPHIC SURVEY OF THE LDEF MISSION

NASA Special Publication 531

Robert L. O'Neal

National Aeronautics and
Space Administration

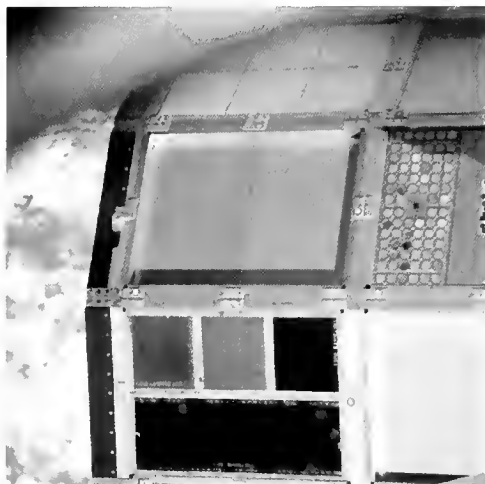
Figure 65 (In Flight). The test panel discoloration pattern visible in the prelaunch photograph remained unchanged. The identification numbers on all panels changed to a light brown. The ripple patterns on the polyimide panels were the result of manufacturing techniques and were not caused by exposure to space.

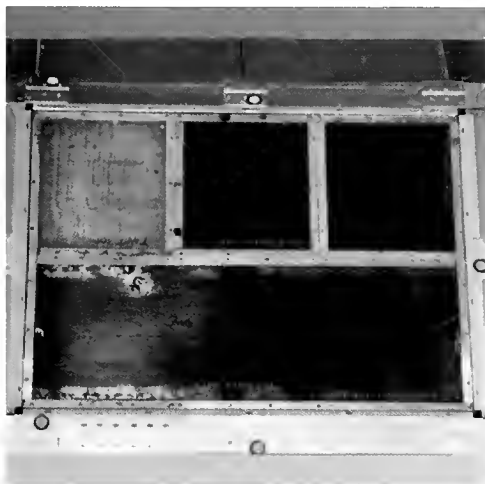
Figure 66 (Postflight). This photograph shows considerably more detail than the in-flight photograph. The horizontal lines on the honeycomb panel that appear to be cracks from space exposure are fine lines of excess epoxy resin that were formed during the manufacturing bagging and curing process. The harsh white of the epoxy adhesive along the rivet lines is from the lighting conditions in the OPF. The greater detail shows that a stain exists at most composite and mounting strip interfaces.

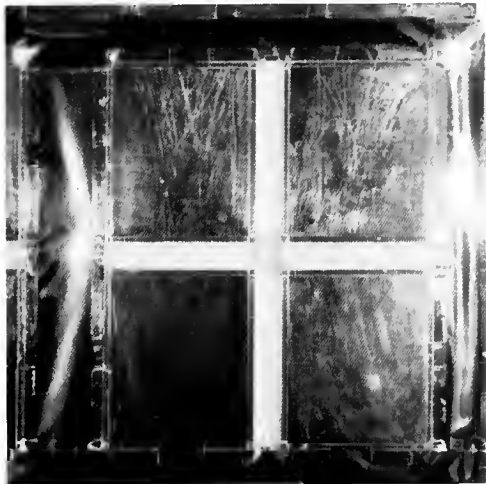
Figure 163 (Postflight). This photograph is of the upper right one-sixth of the tray. It shows the experiment with no apparent physical damage. Surfaces remain highly reflective.
